**Cluster Site Ref. 9
Carminow Cross Roundabout**

**Cluster Site Ref. 4
Pengelly**

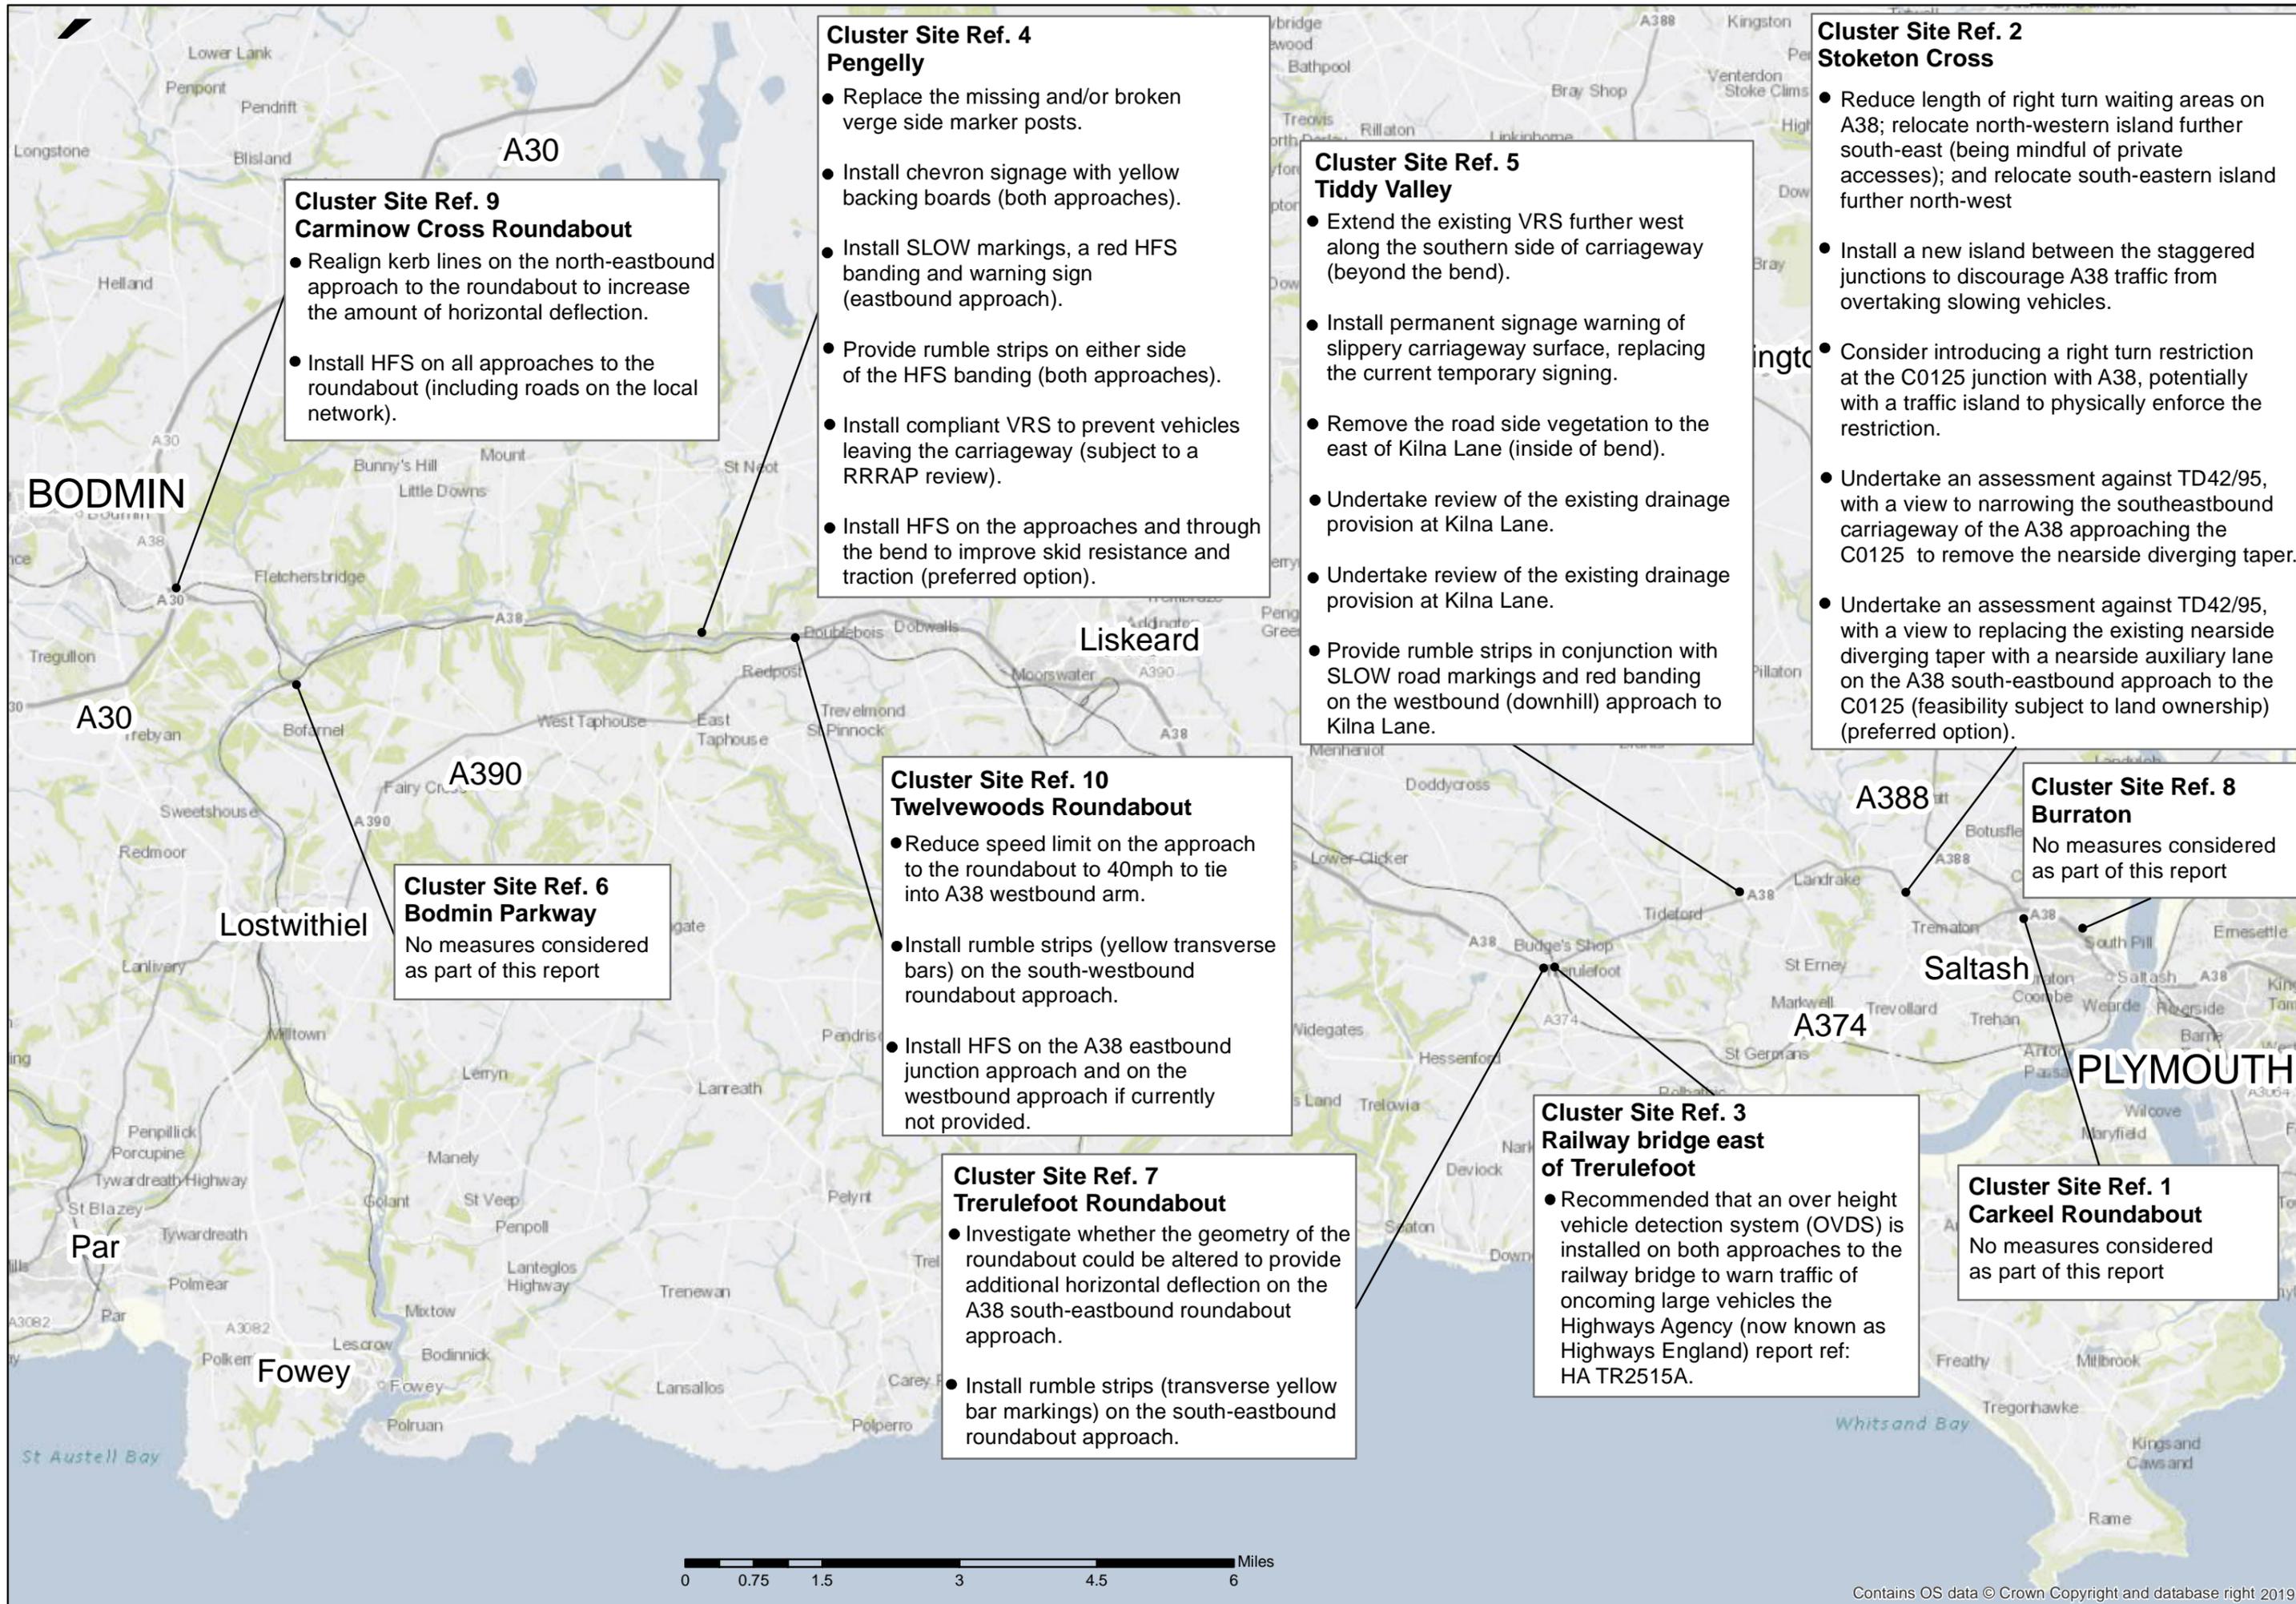
- Realign kerb lines on the north-eastbound approach to the roundabout to increase the amount of horizontal deflection.
- Install HFS on all approaches to the roundabout (including roads on the local network).

- Replace the missing and/or broken verge side marker posts.
- Install chevron signage with yellow backing boards (both approaches).
- Install SLOW markings, a red HFS banding and warning sign (eastbound approach).
- Provide rumble strips on either side of the HFS banding (both approaches).
- Install compliant VRS to prevent vehicles leaving the carriageway (subject to a RRRAP review).
- Install HFS on the approaches and through the bend to improve skid resistance and traction (preferred option).

**Cluster Site Ref. 5
Tiddy Valley**

- Extend the existing VRS further west along the southern side of carriageway (beyond the bend).
- Install permanent signage warning of slippery carriageway surface, replacing the current temporary signing.
- Remove the road side vegetation to the east of Kilna Lane (inside of bend).
- Undertake review of the existing drainage provision at Kilna Lane.
- Undertake review of the existing drainage provision at Kilna Lane.
- Provide rumble strips in conjunction with SLOW road markings and red banding on the westbound (downhill) approach to Kilna Lane.

**Cluster Site Ref. 2
Stoketon Cross**

- Reduce length of right turn waiting areas on A38; relocate north-western island further south-east (being mindful of private accesses); and relocate south-eastern island further north-west
- Install a new island between the staggered junctions to discourage A38 traffic from overtaking slowing vehicles.
- Consider introducing a right turn restriction at the C0125 junction with A38, potentially with a traffic island to physically enforce the restriction.
- Undertake an assessment against TD42/95, with a view to narrowing the southeastbound carriageway of the A38 approaching the C0125 to remove the nearside diverging taper.
- Undertake an assessment against TD42/95, with a view to replacing the existing nearside diverging taper with a nearside auxiliary lane on the A38 south-eastbound approach to the C0125 (feasibility subject to land ownership) (preferred option).

**Cluster Site Ref. 10
Twelwwoods Roundabout**

- Reduce speed limit on the approach to the roundabout to 40mph to tie into A38 westbound arm.
- Install rumble strips (yellow transverse bars) on the south-westbound roundabout approach.
- Install HFS on the A38 eastbound junction approach and on the westbound approach if currently not provided.
